FOUNDATION REPORT

SMITHLAND DAM

OHIO RIVER

PHOTOGRAPHS AND FOUNDATION MAPS

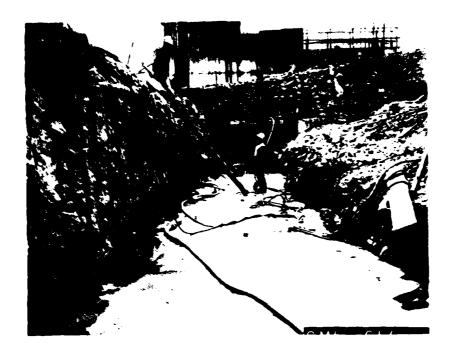
10. Cut-off trench, Gate Bay No. 7, Solution cavity in downstream face. 24 May 77

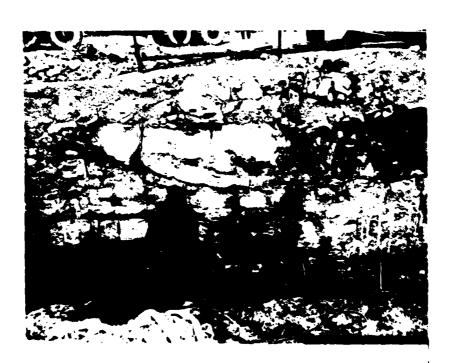
13. Cut-off trench, Gate Bay No. 9, View from Pier 10 looking toward Pier 9. 23 Jun 77

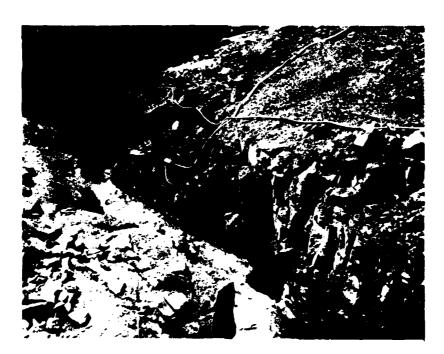
15. Cut-off trench, Gate
Bay No. 10, View from
Pier 10 towards Pier 11.
30 Jun 77

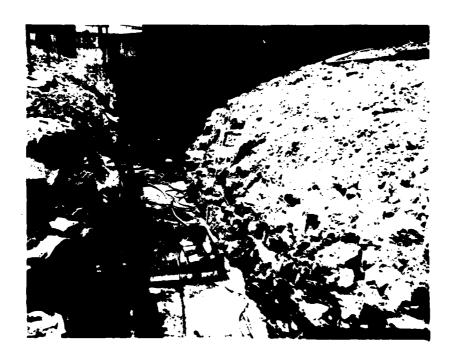
17. Cut-off trench, Gate Bay No. 11, View from Pier 12. 30 Jun 77

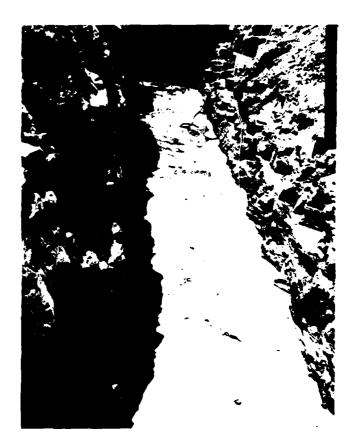
18. Looking down stilling basins from lockwall to Ky. Note Overbreak. 12 Jun 78

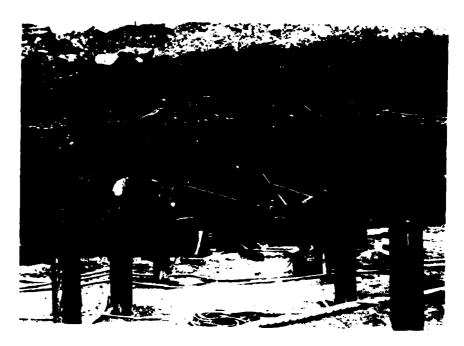
21. Solution channel in 10' strip, Gate Bay No. 2, Sta. 72+50S to 72+60S, Sta. 0+39.50 to 0+49.50, Looking upstream. 19 Dec 77

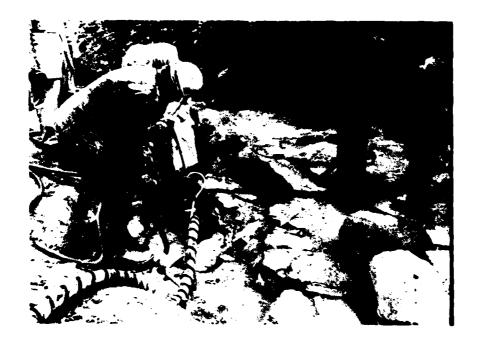
23. Downstream face, Stilling Basin No. 5, Illinois 1/4 of bay, Undergoing final clean-up, Bottom Elev. 253.5[±]. 5 Apr 78

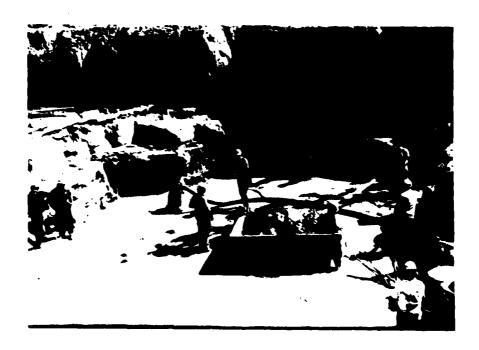
24. Upstream face, Gate Bay No. 5. 31 May 77

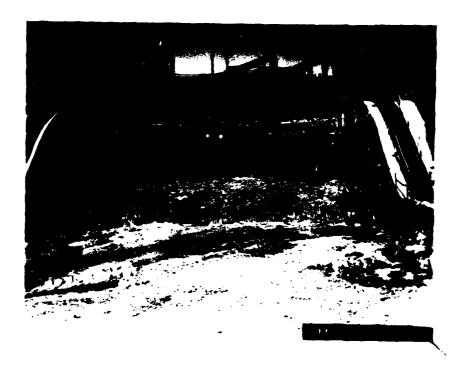
25. Looking downstream into Stilling Basin No. 5 from tainter gate.
Solutioned area on right prior to removal. Trench through rest of bay later cleaned out and filled with dental concrete. 4 Apr 78

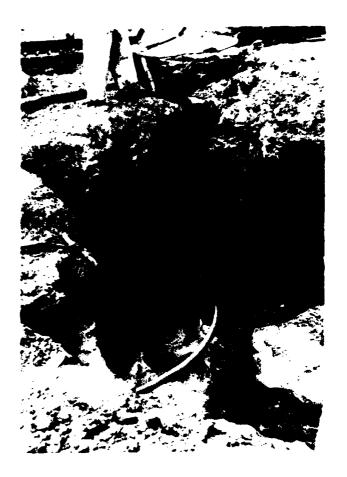
27. Solution channel, Stilling Basin No. 6, Illinois side and downstream of Pier 7. 3 May 78

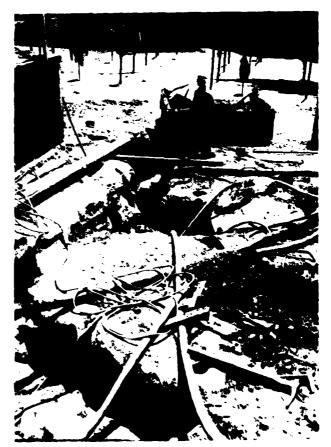
28. Solution channel Stilling Basin No. 6, Ky. Side of Pier 6, 27 Apr 78

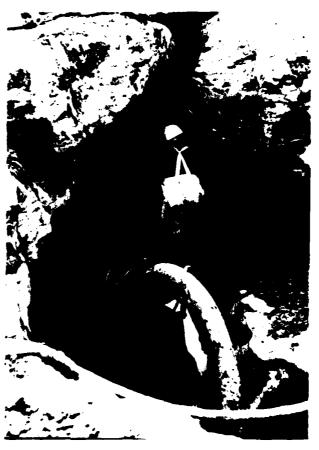
29. Stilling Basin No. 7, Looking toward Kv. 8 May 78

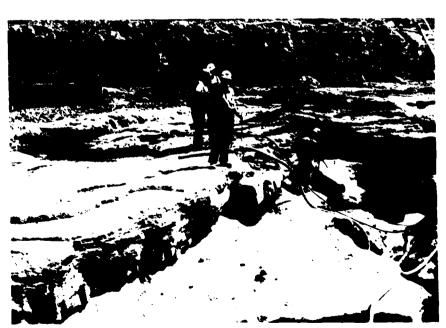
32. Stilling Basin No. 9, Hole in upstream III. corner, Due to overbreak and solution channel. 31 Jun 78

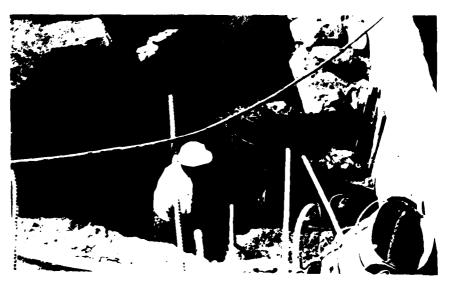
33. Kentucky half of Stilling
Basin No. 9, Low area just
downstream of ogee section
which was placed separately
to level foundation for
anchor rod installation.
15 Jun 78

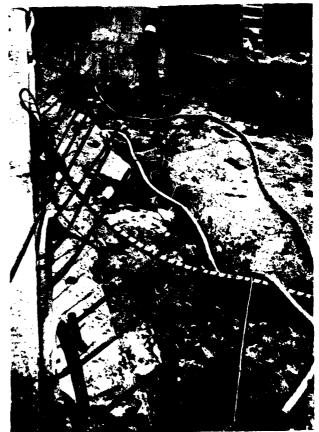
34. Stilling Basin No. 10, Looking from Pier 10 at installation of rock anchors. 30 Jun 78

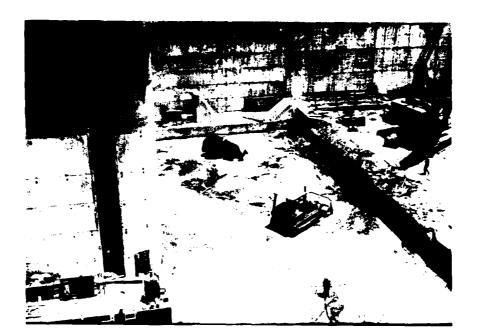
37. Pier No. 1, Presplit line looking downstream from Sta. 1+270. 25 Aug 76

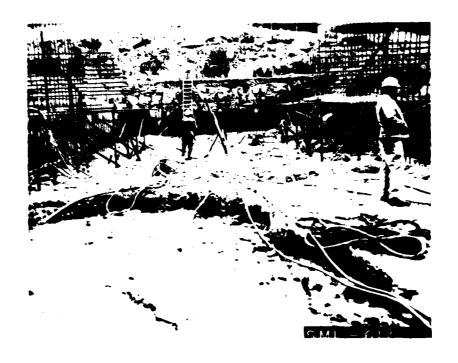
44. Pier No. 2, Illinois side in area of cut-off trench. 15 Oct 76

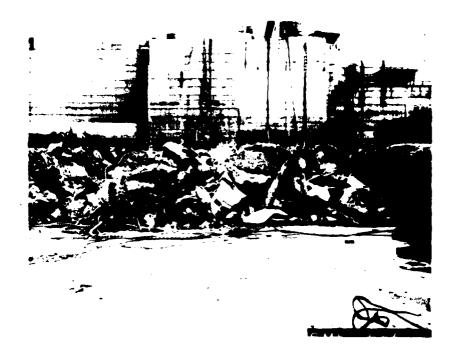
46. Pier No. 3, View along center line showing Ky, side prior to form work. 16 Oct 76

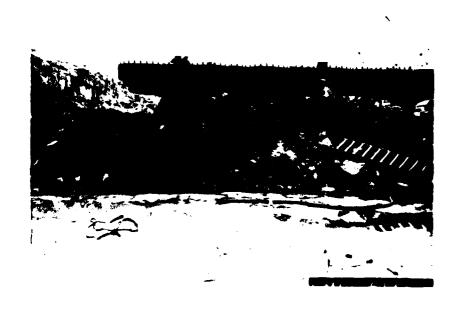
47. Pier No. 3, View from inside excavation showing downstream rock face. 20 Oct 76

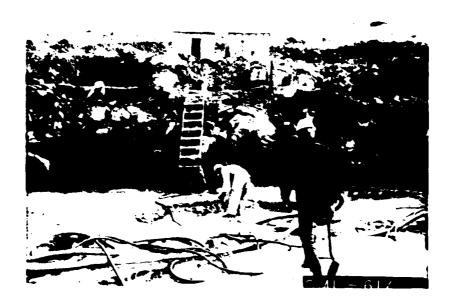
48. Pier No. 4, Unstream Ill. corner. 18 Nov 76

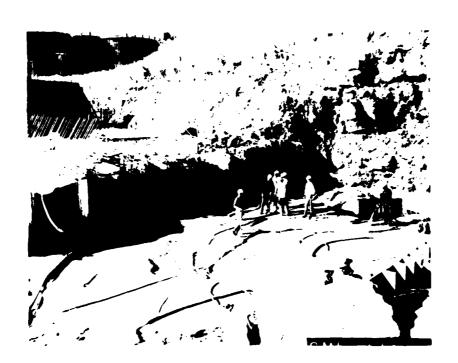
49. Pier No. 4, View from downstream III. side showing downstream face and Ky. corner of excavation. 18 Nov 76

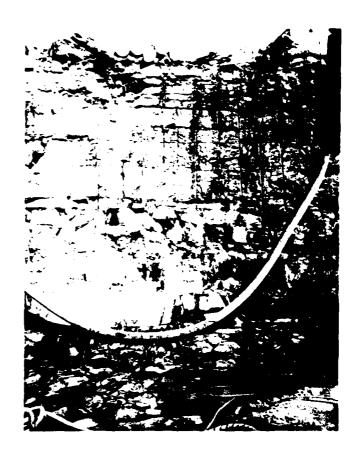
60. Pier No. 6, Overbreak on downstream end of Pier 6. Ruler at approx. neat line. View from Ev. side. 22 Feb 77

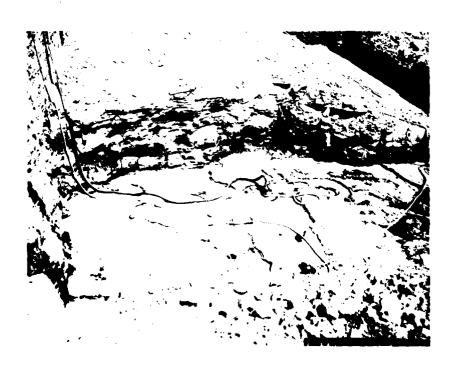
63. Pier No. 7, View of upstream III. side. Solutioning at founding Elev. 250^{\pm} . 12 May 77
